THE MELTON HILL PROJECT

A REPORT ON THE PLANNING, DESIGN, CONSTRUCTION,
INITIAL OPERATIONS, AND COSTS

TECHNICAL REPORT No. 15

TENNESSEE VALLEY AUTHORITY
KNOXVILLE, TENNESSEE

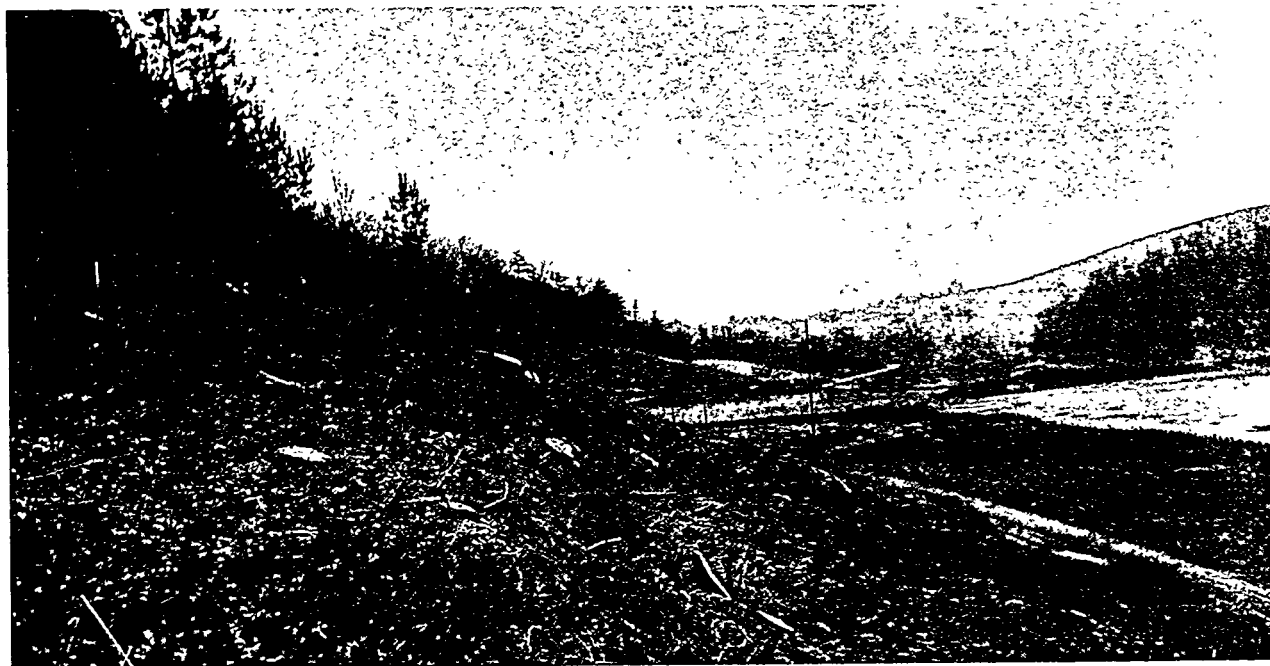
FIGURE 141.—Trees were generally cut with stumps no higher than 4 in. Low cutting removed navigation hazards and permits machine mowing for plant growth control.

Navigation Branch all trees above El. 779 and below 796 were cut 4 in. or less above ground level to clear the channels of navigation hazards. Another reason for low stumping was to permit machine mowing between the 790 and 796 contours for plant growth control. Low stumping was a very difficult task, particularly along the steep riverbanks where it became necessary to uproot many of the larger stumps and burn them. This contributed to the high overall clearing cost. All nonsalvageable timber, logs, brush tops, rooted out stumps, and other material which might float or collect flottage were piled and burned or otherwise disposed of.

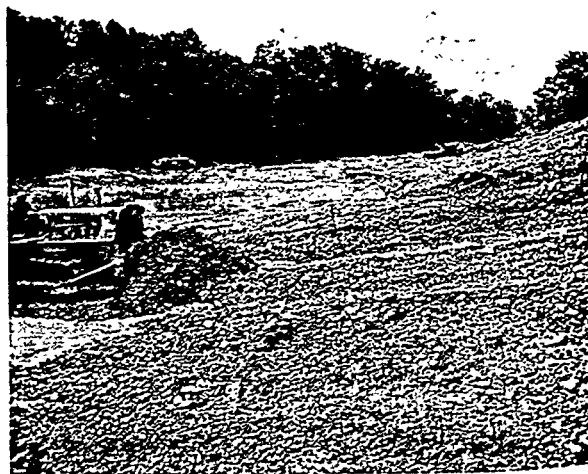
FIGURE 142.—By virtually stopping the flow of the Clinch River at Norris Dam, 19 miles upstream, it was possible to excavate to channel bottom grade with dry-land equipment.

ment (fig. 142), and the job was completed in a minimum of time. It was estimated that regulating the streamflow reduced the cost of dredging about \$229,000.

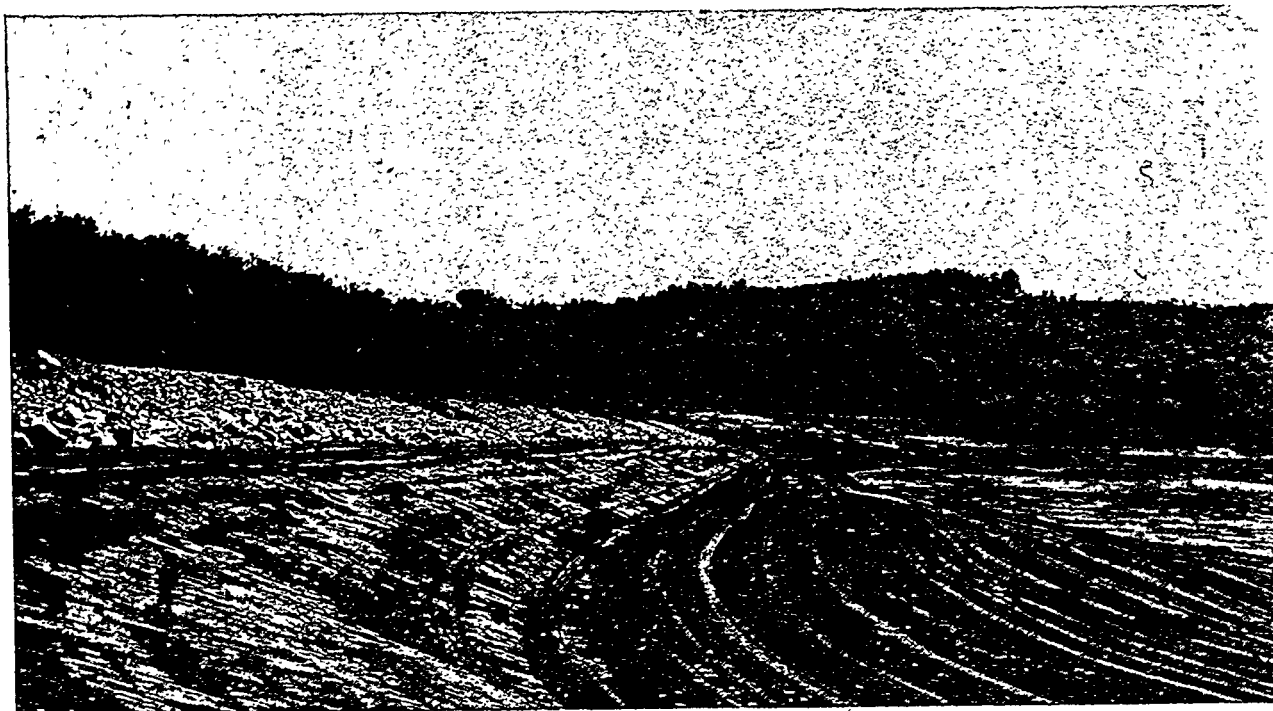
FIGURE 145.—Safety landings are usually established at about 5-mile intervals where practicable. At mile 46.6 one was prepared along the ash disposal dike at the Bull Run Steam Plant.

Two small islands were graded to channel bottom at mile 53.4, rock outcroppings were removed from the safety landing at mile 50.6, and extensive grading was required in a safety landing at mile 46.6 (fig. 145). Concrete mooring posts, cables, and mooring rings were installed in the safety landings at miles 46.6 and 50.6 (fig. 146).

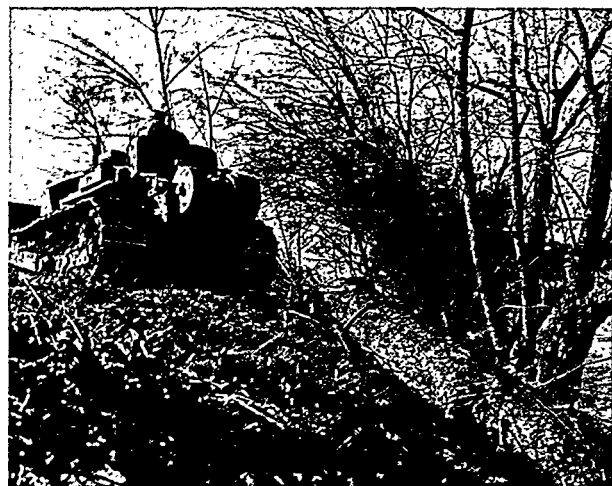
FIGURE 151.—Riverbank clearing often required that large trees be allowed to fall into the water. They were later towed up the riverbanks and piled for burning.
